Tristan Lee
Performance Engineer
AES Corporation

Improving wind-turbine performance with PLCs

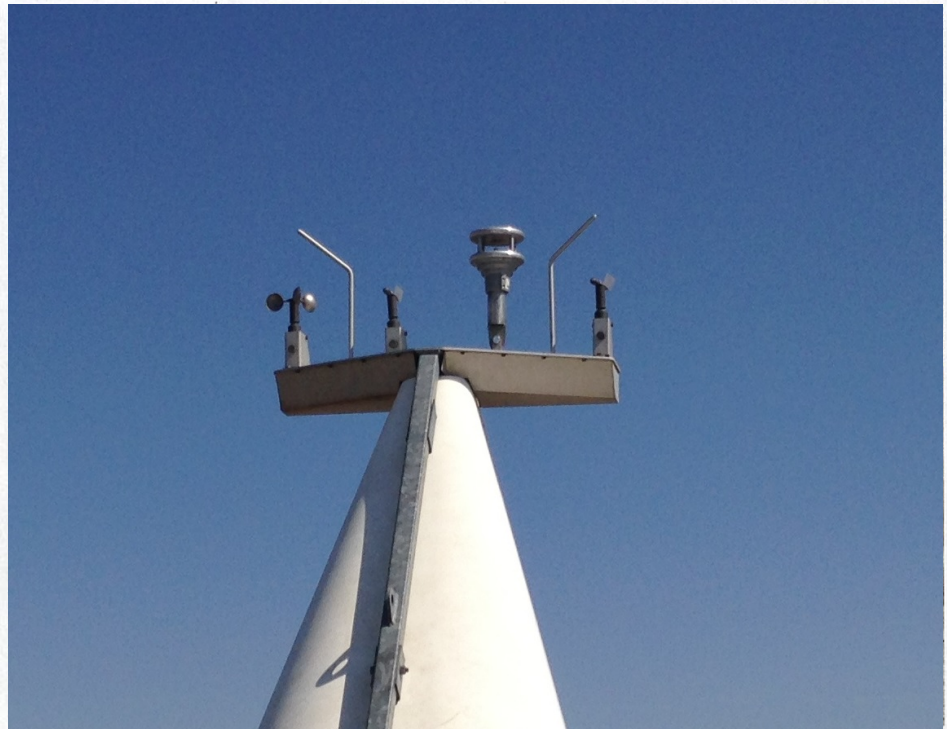
An ultrasonic sensor (the round dome) mounted on top of a turbine showed it could measure wind speed and direction more accurately than the OEM's mechanical anemometer and wind vane, providing vital information to the PLC.

Based on this assessment, engineers replaced the wind measurement mechanical sensors with a single ultrasonic sensor (see image, *An ultrasonic sensor*) and used an IDEC programmable logic controller (PLC) to convert signals from the sensors and gain better control the wind turbines. IDEC is a manufacturer of control, operator interface, and other automation components. The company's controller proved reliable, user-friendly, and affordable, which was imperative for a site that needed to install a total of 296 of these components.

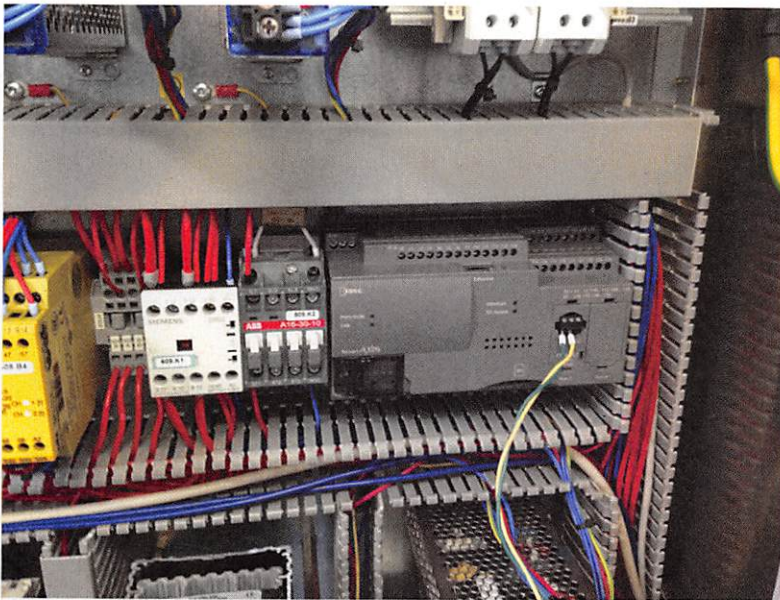
The new IDEC PLC with power supply and the existing turbine controller, all fit into a wind turbine's nacelle.

The engineers were also able to create algorithms to provide non-linear corrections to dynamics, such as the nacelle transfer function and yaw bias. All the IDEC equipment and a 240W power supply fit into a turbine's nacelle, along with the existing OEM turbine controller.

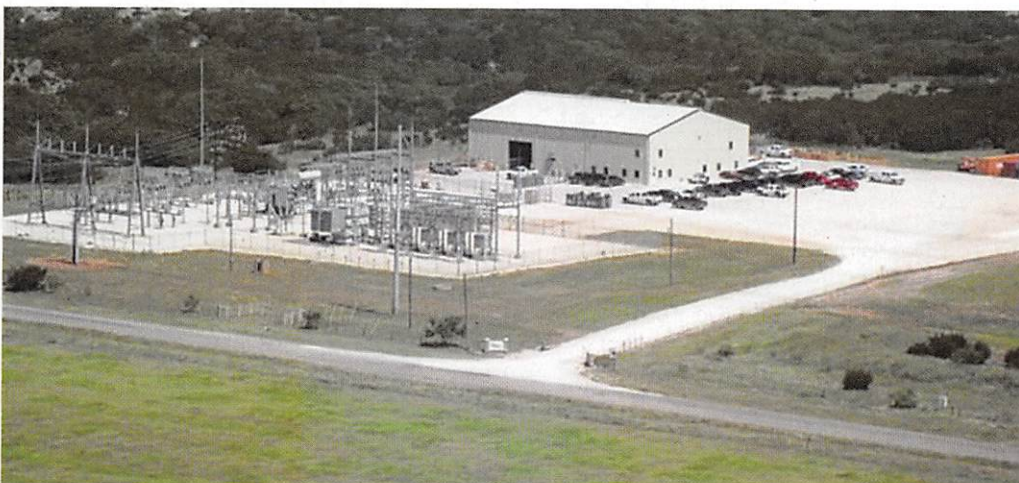
Data from the IDEC PLCs is transmitted to AES Corporation's control center for analysis.

Data from the PLCs is transmitted to a control center where engineers perform statistical analysis, program the PLCs and turbine controllers, and analyze data to predict failures before they happen.
